3rd Quarter, 2003

GMS NEWS

Another Tooth-Top Cracking Elimination Without A Rewind In Only 21 Days

Rapid Solution to a Nuclear Plant Exciter Problem

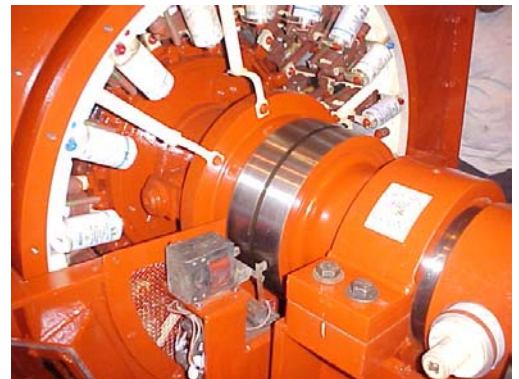
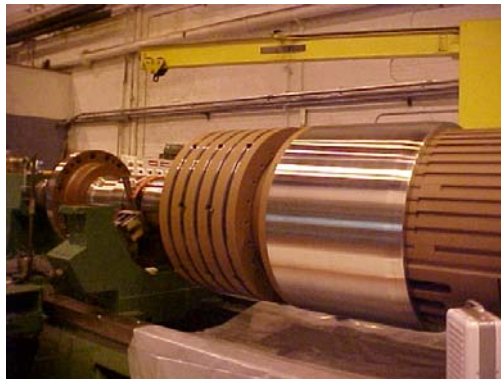
During the 2003 Spring outage period, another tooth-top cracking repair was completed using the patented GMS rotor modification. This was our 6th tooth-top modification over the past 4 outage periods performed for utilities and was completed in just 21 days, without the need for rewinding or balancing the rotor. Within the 21-day turnaround, GMS also machined and replaced the retaining rings; machined the couplings; inspected and tested the rotor; inspected the entire generator; performed both generator electrical and mechanical testing; re-torqued the stator core; completely re-wedged the stator; and performed a complete exciter overhaul. Even shorter turnaround times are achievable, depending on the needs of the customer.

Our scope of work on the tooth-top repair project included an overhaul of the unit's directly connected 1,320 kW Mark III brushless exciter. The scope included inspecting the rotating rectifier, alternator and PMG; disassembling, cleaning and reassembling

the rotating rectifier wheel components; cleaning and testing the exciter alternator and PMG; performing electrical testing of the exciter components; repairing exciter bearings, and aligning the exciter.

After completing the tooth-top modification on the generator rotor, installing new retaining rings and coupling the refurbished and newly aligned exciter, the turbine-generator train experienced a significant reduction in vibration at the exciter end.

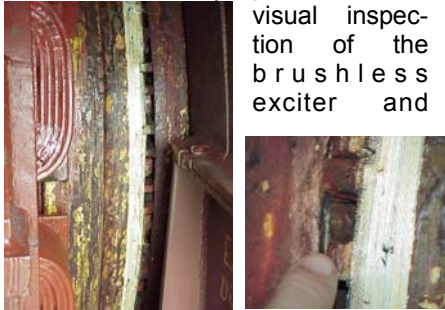
found that parts of the fiberglass banding and two pieces of blocking were lying inside of the exciter housing. The loose banding came from a section covering the leads from the brushless exciter winding at the inboard end of the alternator, as shown in the photographs below.

The GMS team found that banding had peeled from a section where the coils bridge to the radial phase leads connections. The banding in this area is relatively lightly loaded compared to that closer to the core, where the coil end windings are densely packed under the bands. The band that was peeling was 3 inches wide and approximately 0.38-inches thick and the damaged area of the band was about 1.25 inches wide.

After evaluating the damage and assessing the impact, GMS recommended that the loose banding simply be removed and that the remaining banding be coated with a thixotropic epoxy resin to prevent further peeling. GMS personnel concluded that this repair would hold

adequately through continued operation until the next scheduled refueling outage. However, as an added precaution, GMS personnel also recommended that the repaired area be viewed periodically with a strobe light during startup and operation to verify that no further deterioration of the banding was occurring.
